PERFORMANCE AUDIT REPORT ON INSTALLATION AND MAINTENANCE OF ROAD FURNITURE

KENYA NATIONAL HIGHWAYS AUTHORITY
KENYA URBAN ROADS AUTHORITY AND
THE KENYA RURAL ROADS AUTHORITY

NOVEMBER 2020

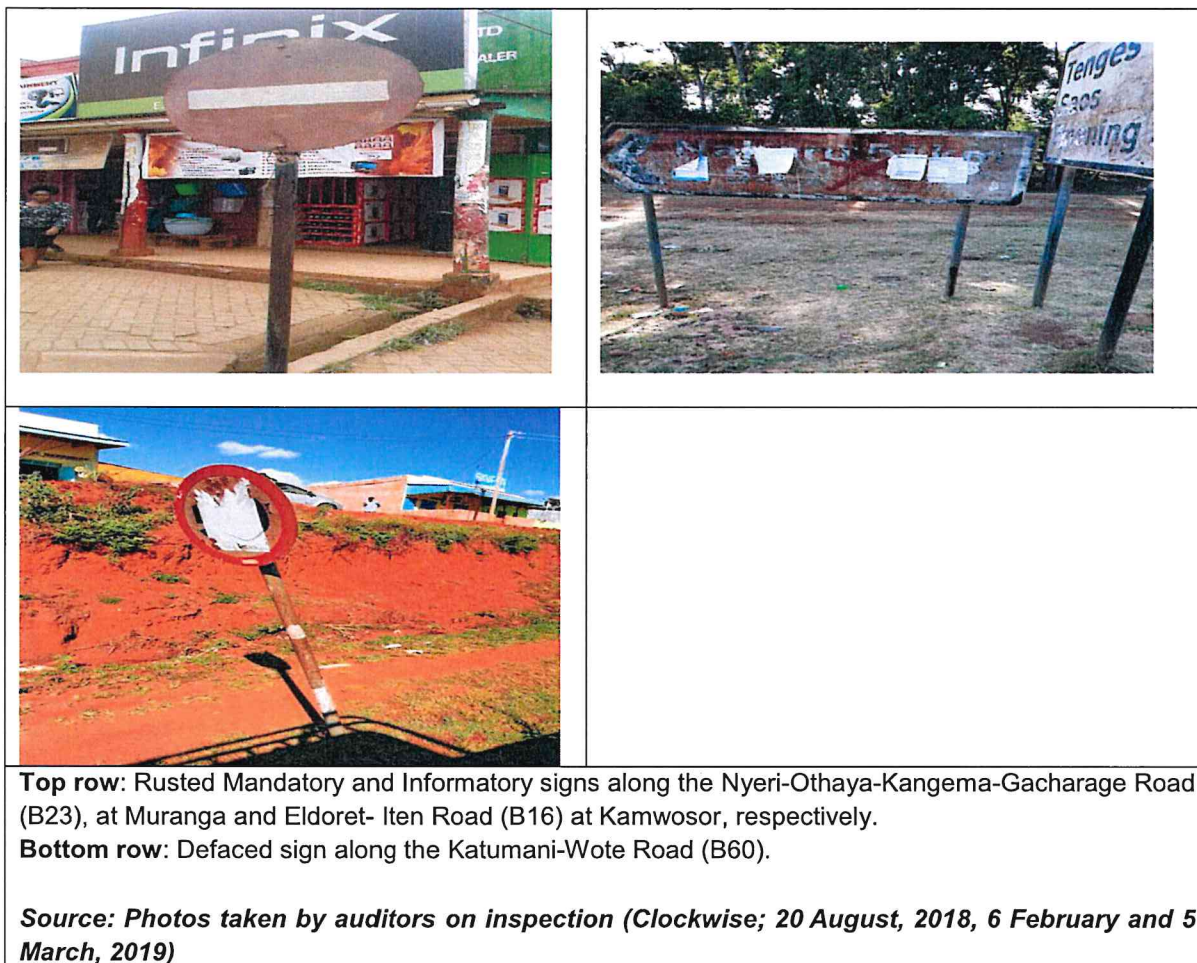
Figure 2: Road Signs that were Defaced, Faded and had Rust

4.14 **Figure 2** shows roads with road signs that were defaced, faded and had rust. These roads were under Performance-Based Contracts that were about to lapse;

- The Nyeri-Othaya-Kangema-Gacharage Road (B23), which had a defaced signage, faded road markings and damaged guardrails;

- ii. The Eldoret-Iten Road (B16) with damaged guardrails; and
- iii. The Katumani-Wote Road (B60) which had a defaced signage.

- 4.15 Minimal or lack of maintenance could be attributed to the fact that road furniture is not given priority during planning for maintenance. This is evident from the ARICS report reviewed that did not capture the condition of road furniture. This means that recommendations on aspects to be included in the work plans for maintenance may lack the necessary work to be carried out on road furniture. Consequently, maintenance may not be adequately done. Lack of maintenance of road furniture has direct and indirect cost as neglected road structures and signs may lead to road accidents.

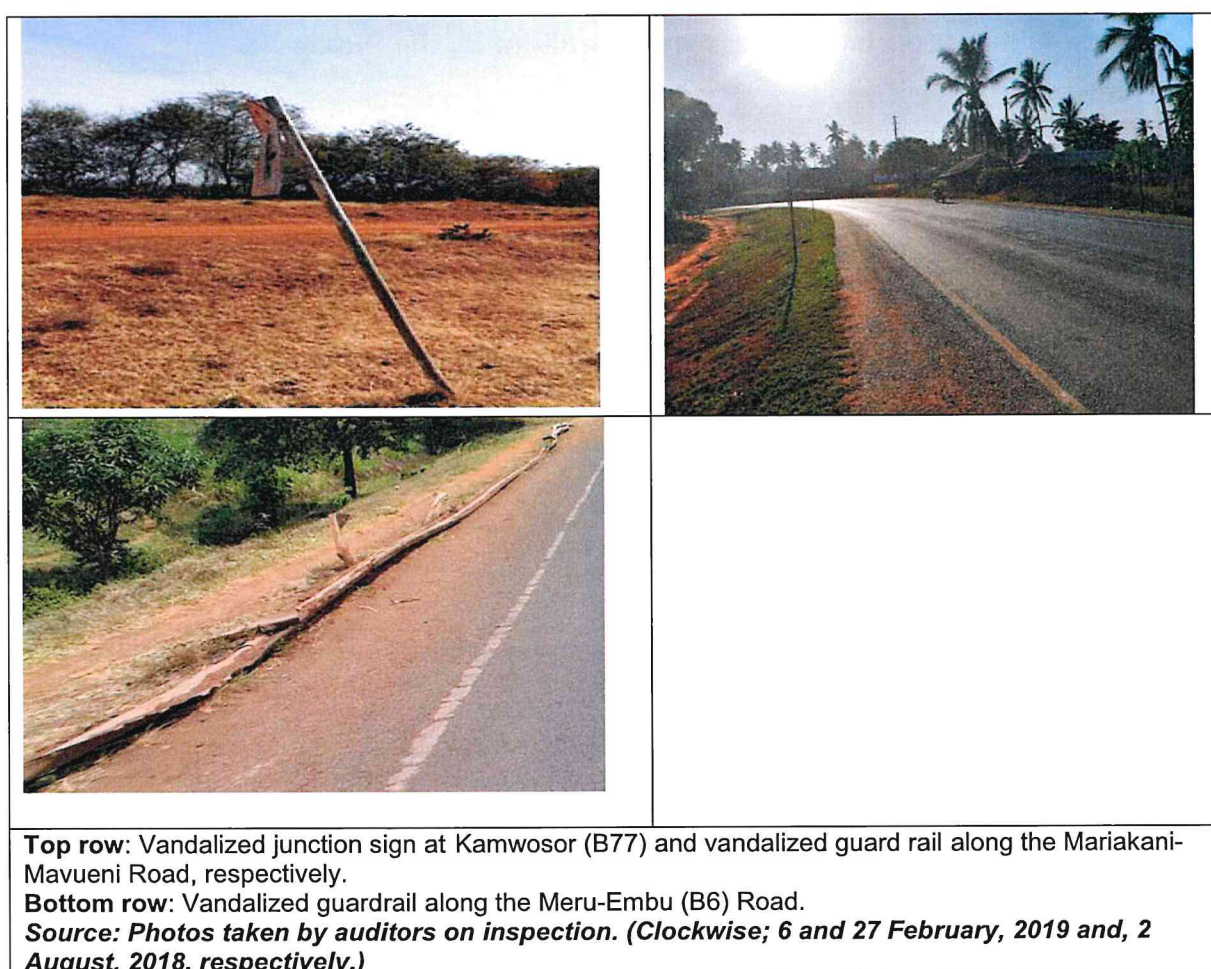
Figure 3: Vandalised Road Furniture

- 4.17 During field visits between January and March 2019, it was observed that there were cases of vandalism of road furniture on the roads inspected. In total, there were 50 vandalized road signs, 40 vandalized guardrails and 14 vandalized bridge rails on the 22 roads inspected. The Gilgil-Mau Summit Road (A8), Machakos-Kitui Road (B62) and Mariakani- Kaloleni- Mavueni Road (B91) are among the roads that had the greatest number of vandalized road furniture as shown on **Appendix 10** and in **Figure 3**.

- 4.18 The sustained vandalism of road furniture can be attributed to inadequate monitoring of road furniture and lack of mechanisms for reporting vandalism which would encourage the road users to promptly report vandalism. It was also noted that the material used for

roads signs, mostly metallic, are more susceptible to vandalism because of the relatively high market value of scrap metal. In addition, the Scrap Metal Act, enacted in 2015 to make provisions for the regulation of dealing in scrap metals had not been operationalised by the Ministry of Trade and Industry at the time of the audit.

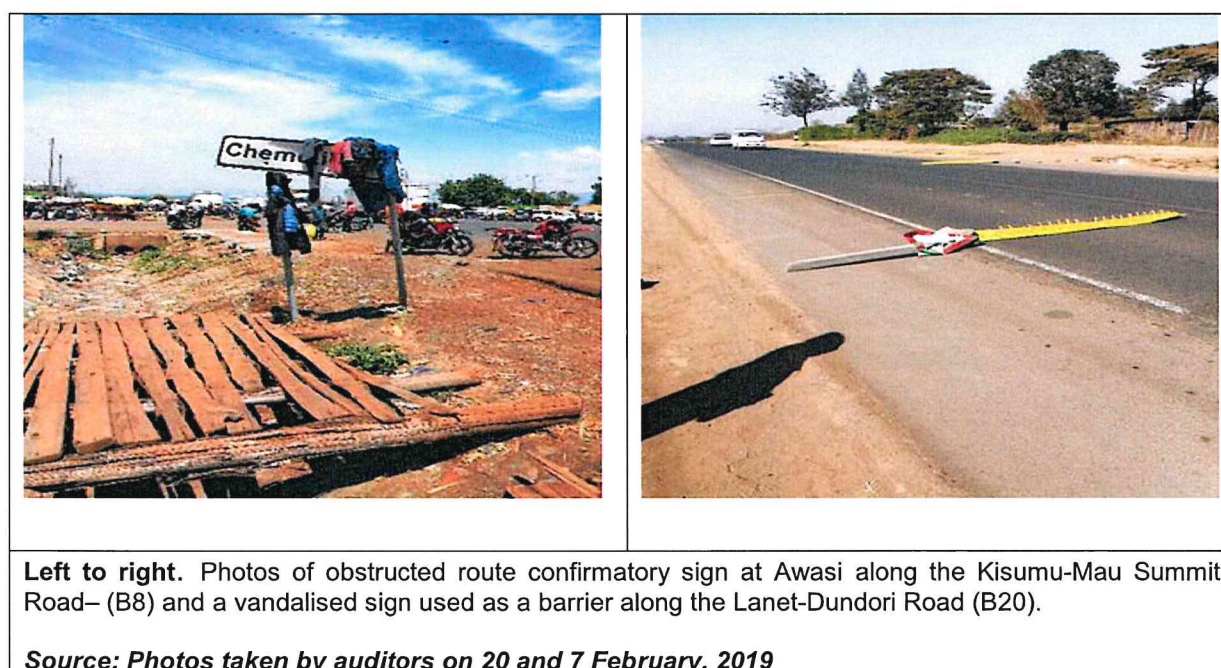
Figure 4: Inappropriate use of Road Furniture by the Public

- 4.19 Interviews conducted during the audit revealed that KeNHA does not carry out adequate sensitization campaigns to educate the public on the importance of protecting road furniture. The Regional Offices were allocated Ksh. 3 million every year for sensitisation and demarcation of road reserves. The officers interviewed revealed that a large proportion of this funding is mainly prioritised for demarcation of road reserves and sensitisation of the public. This is particularly in areas where the Authority is planning to demolish structures that are on road reserves. **Figure 4** shows inappropriate use of road furniture by the public.

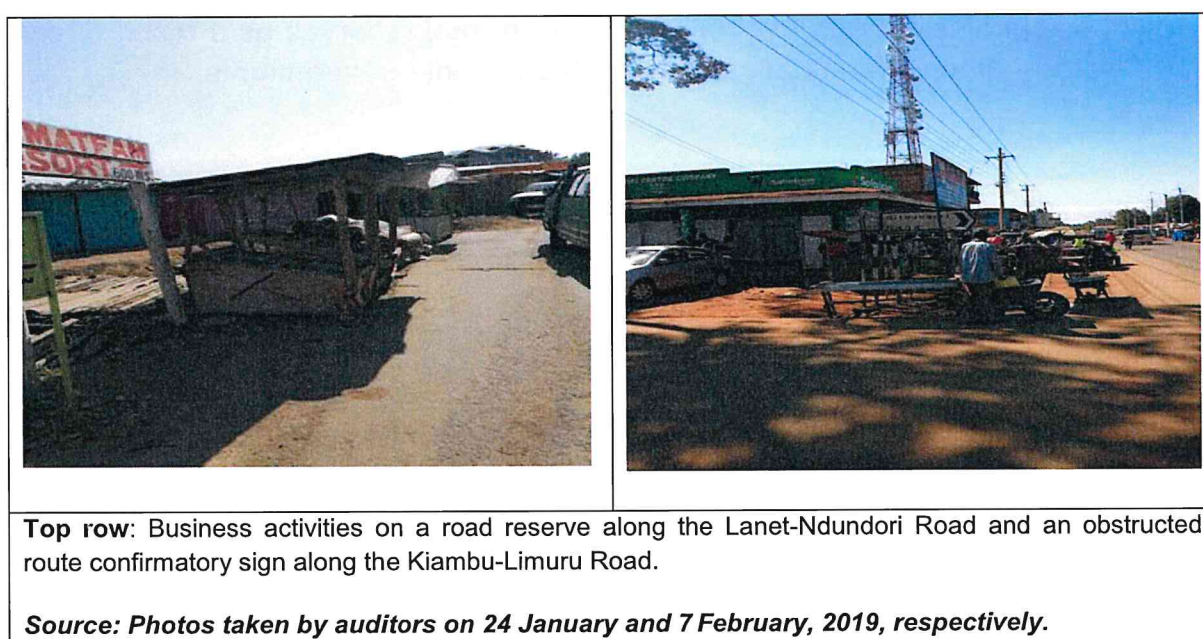
Figure 5: Encroachment along Roads

- 4.22 During the audit inspection between January and March 2019, it was observed that 10 out of 22 roads inspected were not demarcated. For instance, the Eldoret-Kapsabet Road (B8), Ekeru-Ebuyango Road (C781), Kiambu-Limuru Road (B32), Lanet-Ndundori Road (B20) and Mavueni-Sabasaba Road (A7) had been encroached with building structures, businesses and farming activities as depicted in **Figure 5**.

- 4.25 Encroachment results to blockage of drainages and obstruction of visibility of road signs, leading to serious compromise on road safety. Failure to collaborate with stakeholders leads to encroachment on road reserves as a result of conflict of interest among various agencies such as county governments.

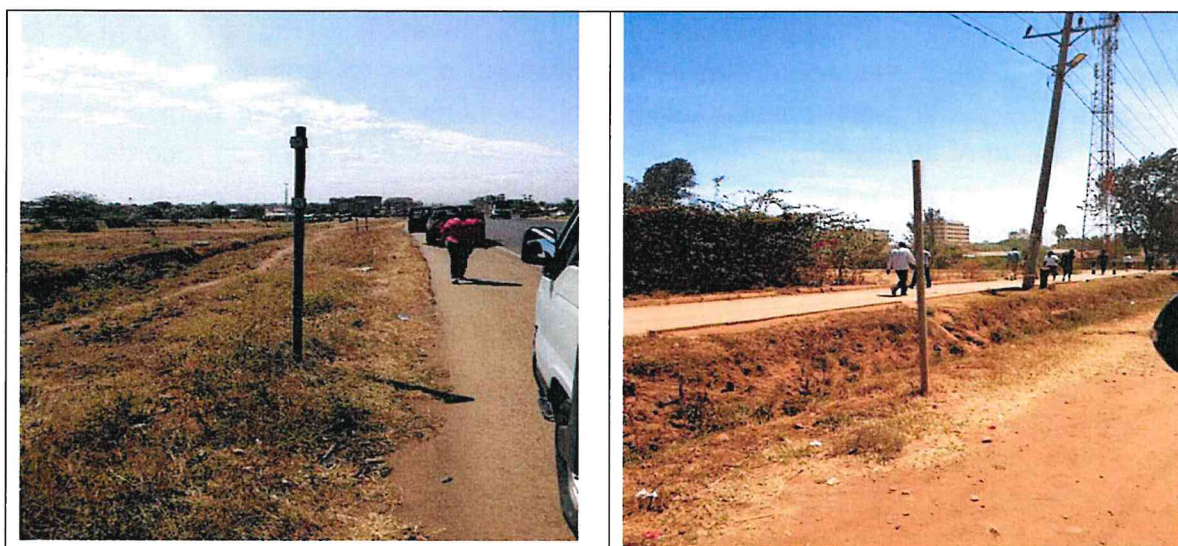
Figure 6: Vandalised Road Furniture

- 4.37 Road Furniture plays an important role in communicating important messages as well as protecting road users. They are important assets and as such should be protected from vandalism.
- 4.38 During field visits in January, February and March, 2019, it was observed that there were cases of vandalism of road signs on the roads inspected. Some of the roads that had vandalised road furniture are Eastern and Northern Bypass, Eldoret-Herman Greener School Road, Kisambai-Sabatia Road in Kakamega and Bangladesh-Baringo Road in Nakuru, among others. **Figure 6** shows photos of vandalised road furniture taken during the audit.

Vandalized road signs along the Eastern By-Pass and Eldoret-Herman Grener Road, respectively.
Source: Photos taken by auditors (24 January and 12 February, 2019, respectively).

- 4.39 The sustained vandalism of road furniture can be attributed to lack of continuous inspection and monitoring of road furniture and lack of mechanisms for reporting vandalism. Reporting mechanisms would encourage road users to promptly report vandalism. It was also noted that the material used for road signs, mostly metallic, is more susceptible to vandalism because of the relatively high market value of scrap metal. In addition, the Scrap Metal Act, enacted in 2015 to make provisions for the regulation of dealing in scrap metals had not been operationalised by the Ministry of Trade and Industry at the time of the audit.

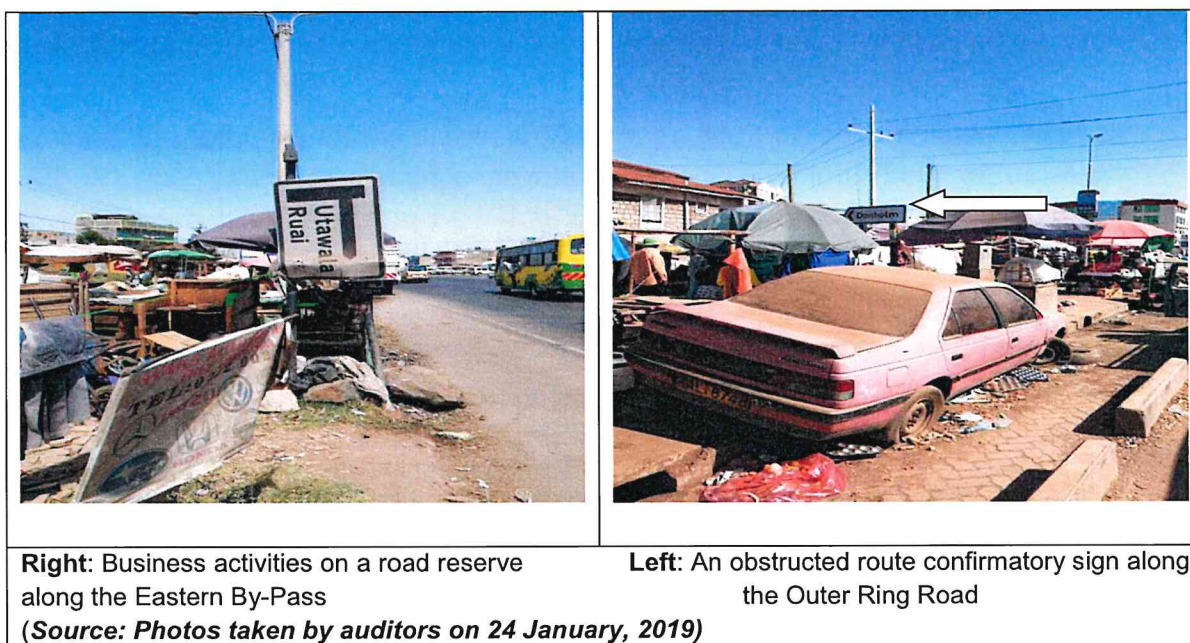
Figure 7: Encroachment on Roads

- 4.43 During the field inspection in February and March 2019, it was observed that all the KURA roads inspected, except for the Eastern Bypass, were not demarcated. It was also observed that 17 out of the 24 roads inspected were encroached. This is depicted in **Figure 7** and **Appendix 12**.

- 4.44 Encroachment results to blockage of drainages and obstruction of visibility of road signs, leading to serious compromise on road safety. Interviews with Regional Managers revealed that collaboration with stakeholders on roadside development activities was not adequate.

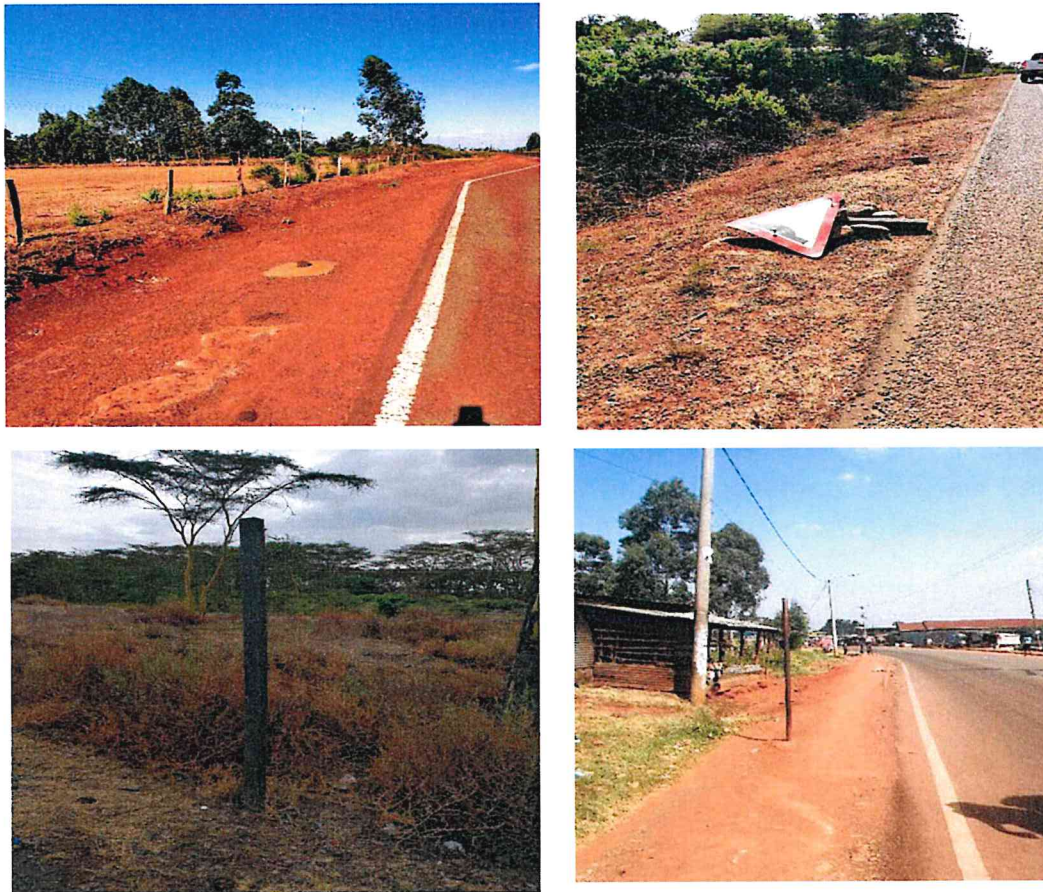
Figure 8: Vandalised Road Furniture

- 4.56 According to the Road Design Manual–Geometric Design for Rural Road Part 1, Chapter 3 (b); road signs and lighting supports and other utility poles should be located far enough from the carriageway to reduce the likelihood of being struck by out of control vehicles, or they should have break-way capability.
- 4.57 During field visits between January and March 2019, it was observed that there were cases of vandalism of road signs on the roads inspected. Some of the roads that had vandalised road furniture are Jua Kali-Sugoi Road, Marula-Kongoni Road, Kabiria Road and SGR-Mkupe Jetty Road among others as shown in **Figure 8**.

Top row: Vandalized road sign along the Jua Kali-Sugoi Road; Uasin Gishu County.

Bottom row: Vandalized road sign along the Marula-Kongoni Road in Nakuru County and Kabiria Road in Dagoretti South; Nairobi County.

- 4.58 The sustained vandalism of road furniture was attributed to lack of monitoring of road furniture and lack of mechanisms for reporting vandalism. Reporting mechanisms would encourage road users to promptly report vandalism. It was also noted that the material used for road signs is susceptible to vandalism because of the relatively high market value of scrap metal. In addition, the Scrap Metal Act, enacted in 2015 to make provisions for the regulation of dealing in scrap metals had not been operationalised by the Ministry of Trade and Industry at the time of the audit.
- 4.59 Document review and interviews revealed that KeRRA did not carry out adequate sensitization campaigns to educate the public on the importance of protecting road furniture. Sensitisation campaigns were planned and carried out by the head office who only manages to cover a few regions in a year.
